Manhole Inspection Summary

Manhole # S35GG_016MH

Insp Date: **10/29/08 12:50 PM**

Location Address: **1401 CHARLES ST**

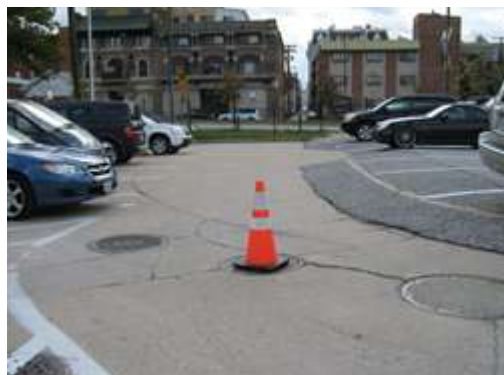
Location View

E. Mt Royal (U of Baltimore parking lot)

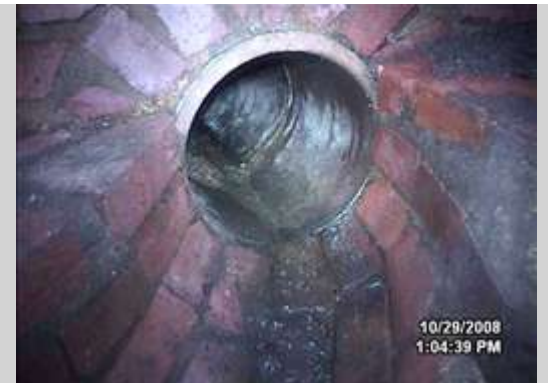
8 in. Circular Gravity Sewer Pipe In @ 3 O'Clock

Rod and Bar (Angled)

Pipe Material: **Clay** ☐ Pipe Lined

Infiltration: **None** Pipe Seal Cond: **Unknown**
